**AFFDL-TR-78-175**  
**Volume III**

**EFFECT OF MULTIAXIAL LOADING  
ON CRACK GROWTH  
Volume III - Compilation of Interferometry Photographs**

*NORTHROP CORPORATION  
AIRCRAFT GROUP  
HAWTHORNE, CALIFORNIA 90250*

*December 1978*

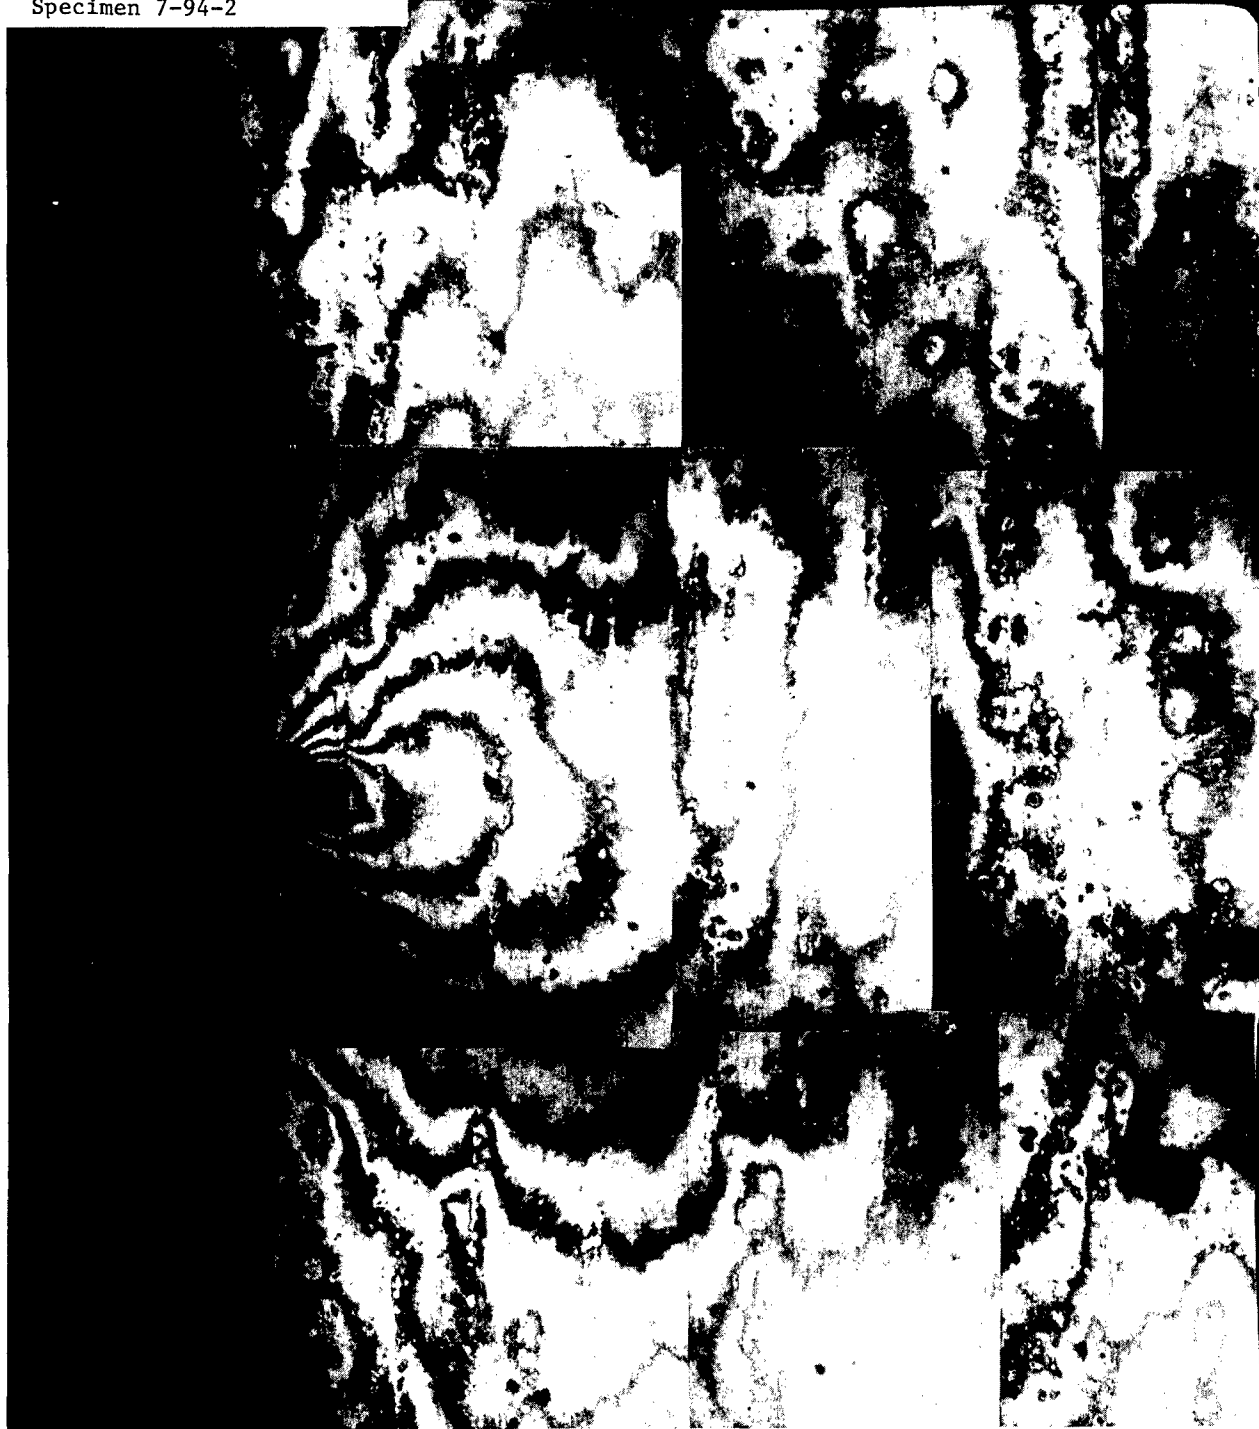
Figure 26. Interferometry Photograph of a Loaded Crack in a 7075-T7351 Specimen

7075-T7351,  $a = 0.25$  inch  
 $\sigma_x = 6$ ,  $\sigma_y = 12$  ksi at load  
Magnification: 46.2X  
Test Case 27  
Specimen 7-94-2

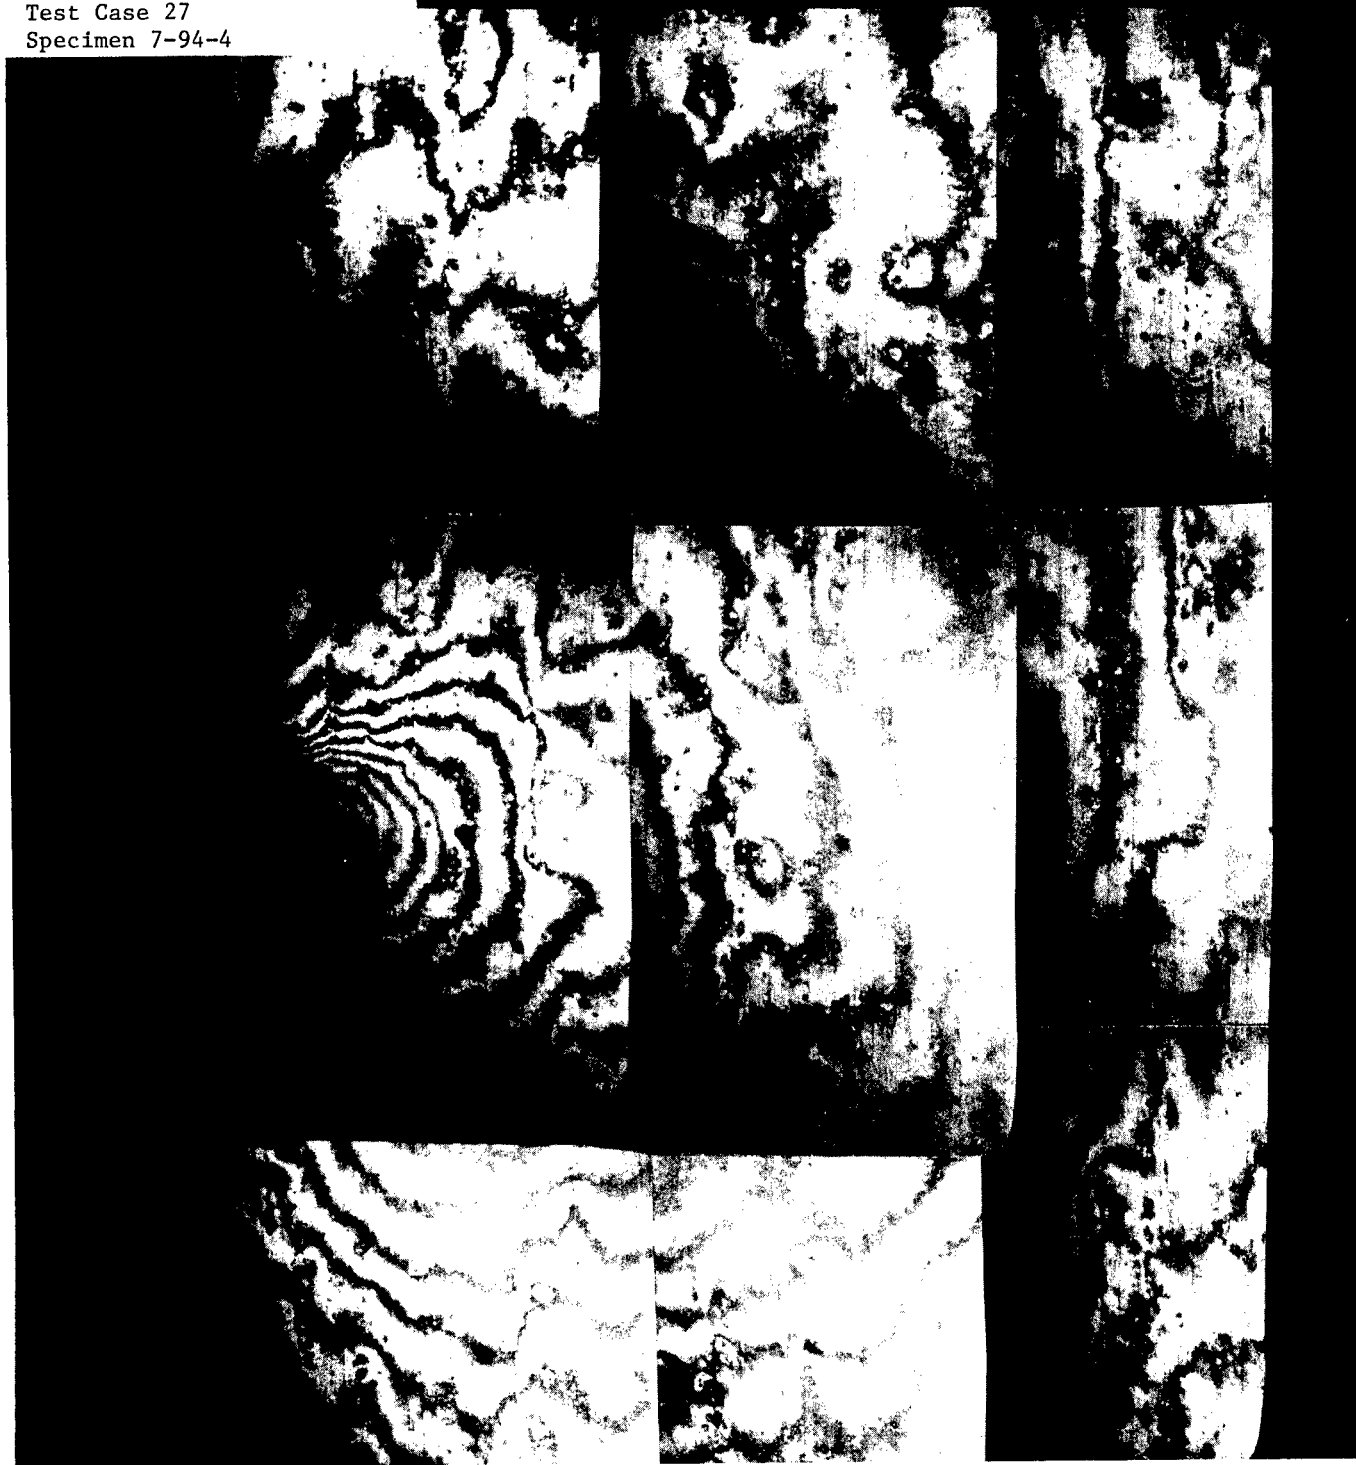
Figure 28. Interferometry Photograph of a Loaded Crack in a 7075-T7351 Specimen

7075-T7351,  $a = 0.495$  inch  
 $\sigma_x = 6$ ,  $\sigma_y = 12$  ksi at load  
Magnification: 45.4X  
Test Case 27  
Specimen 7-94-4

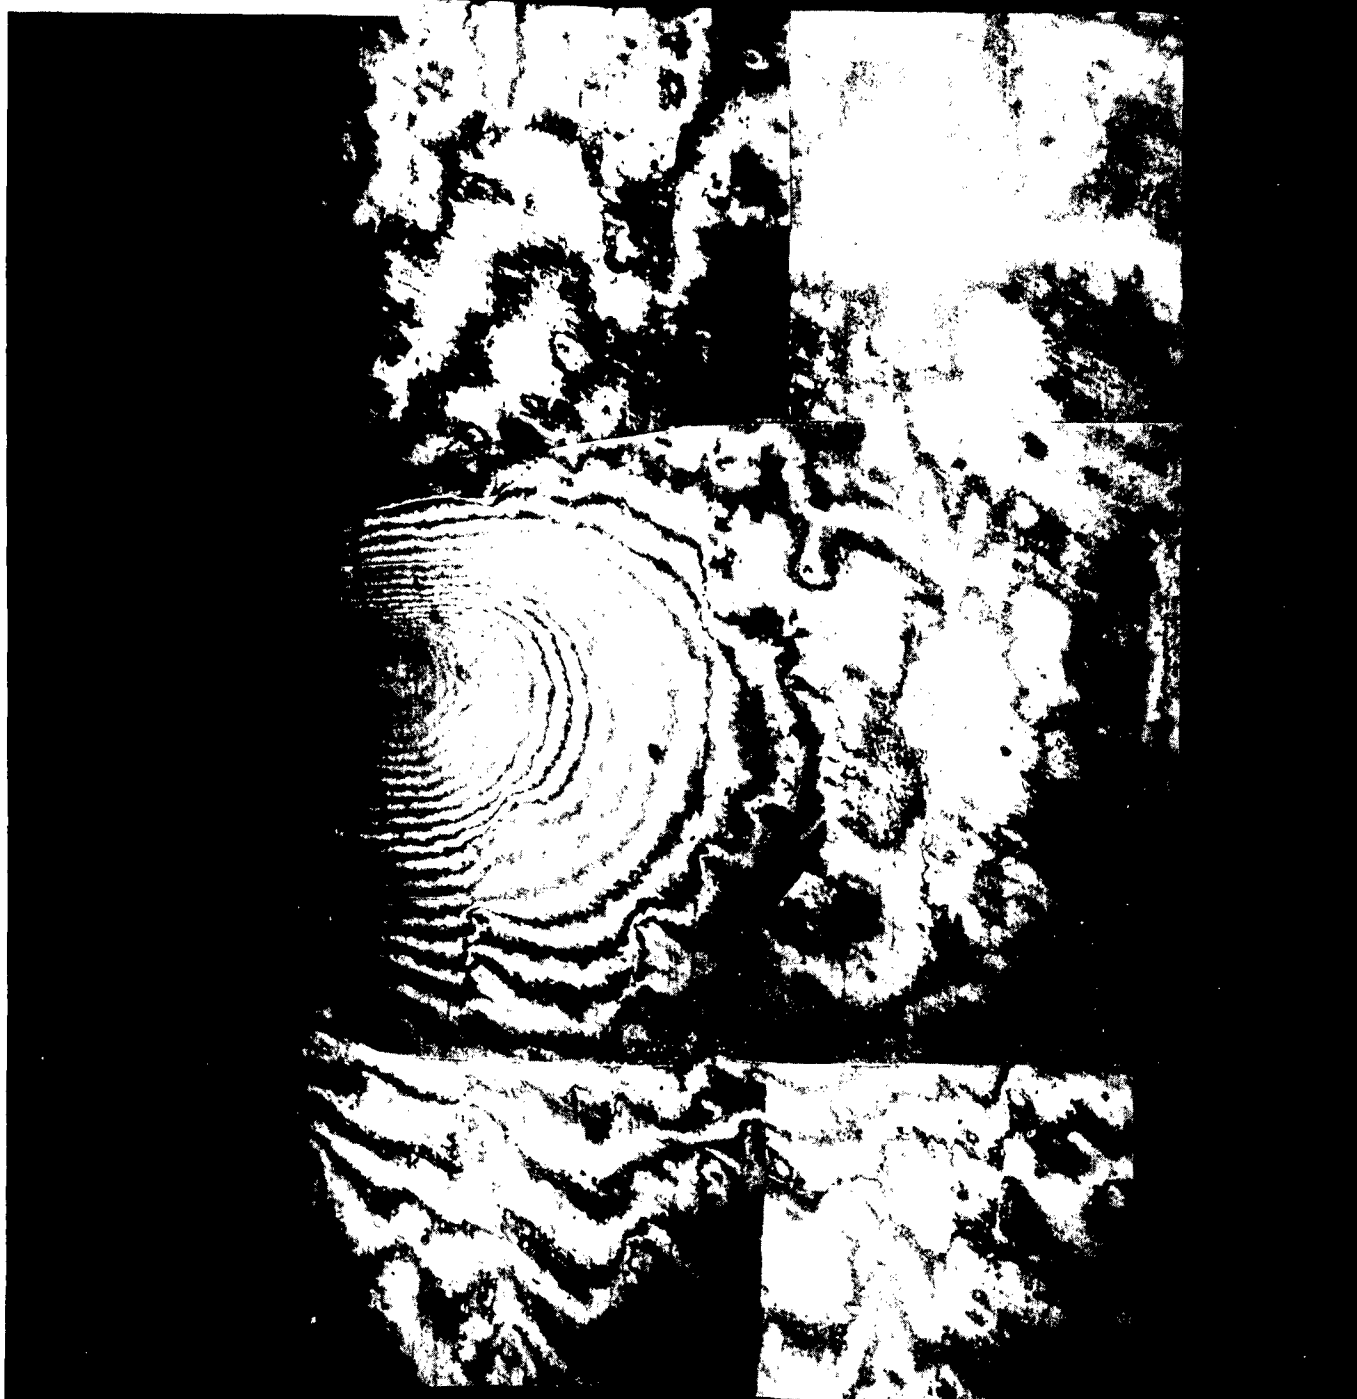
Figure 29. Interferometry Photograph of an Unloaded Crack in a 7075-T7351 Specimen

7075-T7351,  $a = 1.00$  inch  
 $\sigma_x = 6$ ,  $\sigma_y = 12$  ksi unloaded  
Magnification: 45.0X  
Test Case 27  
Specimen 7-94-5

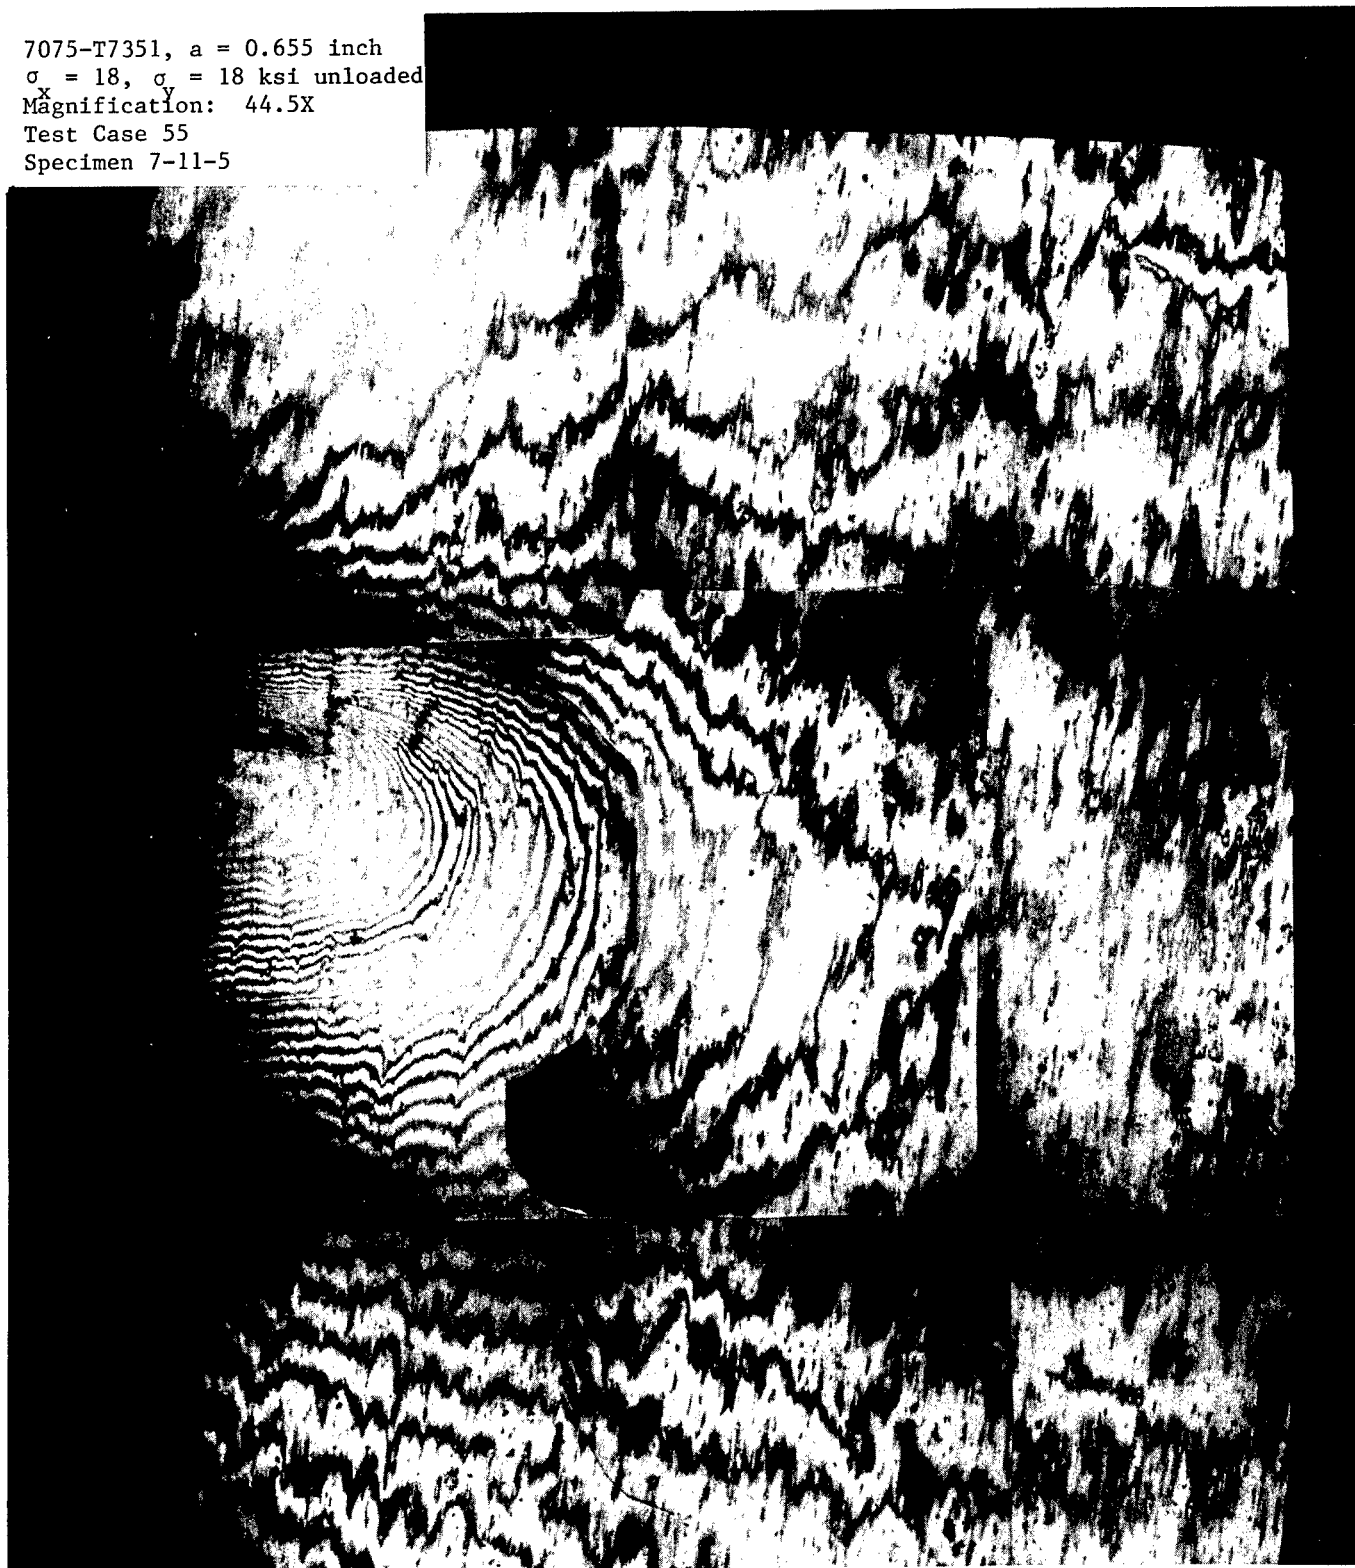
Figure 35. Interferometry Photograph of a Loaded Crack in a 7075-T7351 Specimen

7075-T7351,  $a = 0.655$  inch  
 $\sigma_x = 18$ ,  $\sigma_y = 18$  ksi unloaded  
Magnification: 44.5X  
Test Case 55  
Specimen 7-11-5

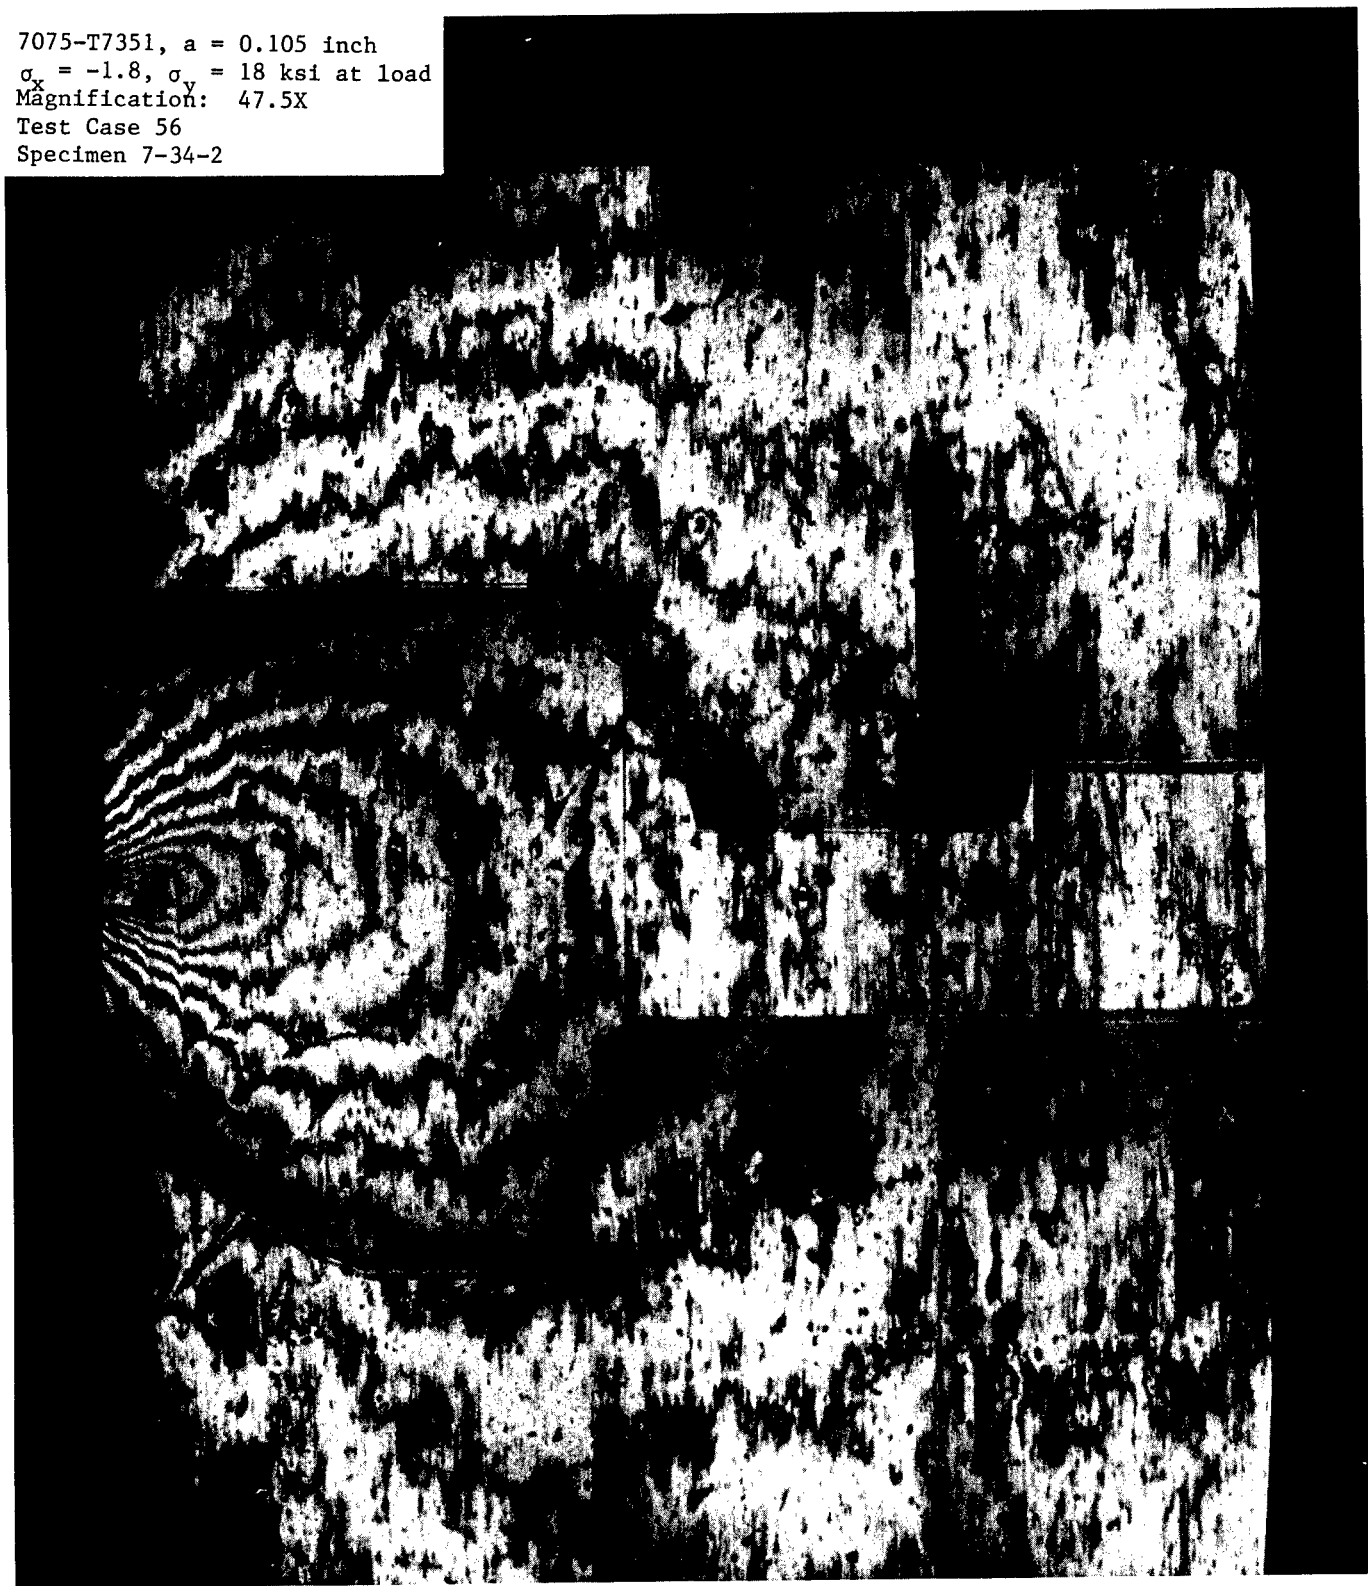
Figure 38. Interferometry Photograph of a Loaded Crack in a 7075-T7351 Specimen

7075-T7351,  $a = 0.105$  inch  
 $\sigma_x = -1.8$ ,  $\sigma_y = 18$  ksi at load  
Magnification: 47.5X  
Test Case 56  
Specimen 7-34-2

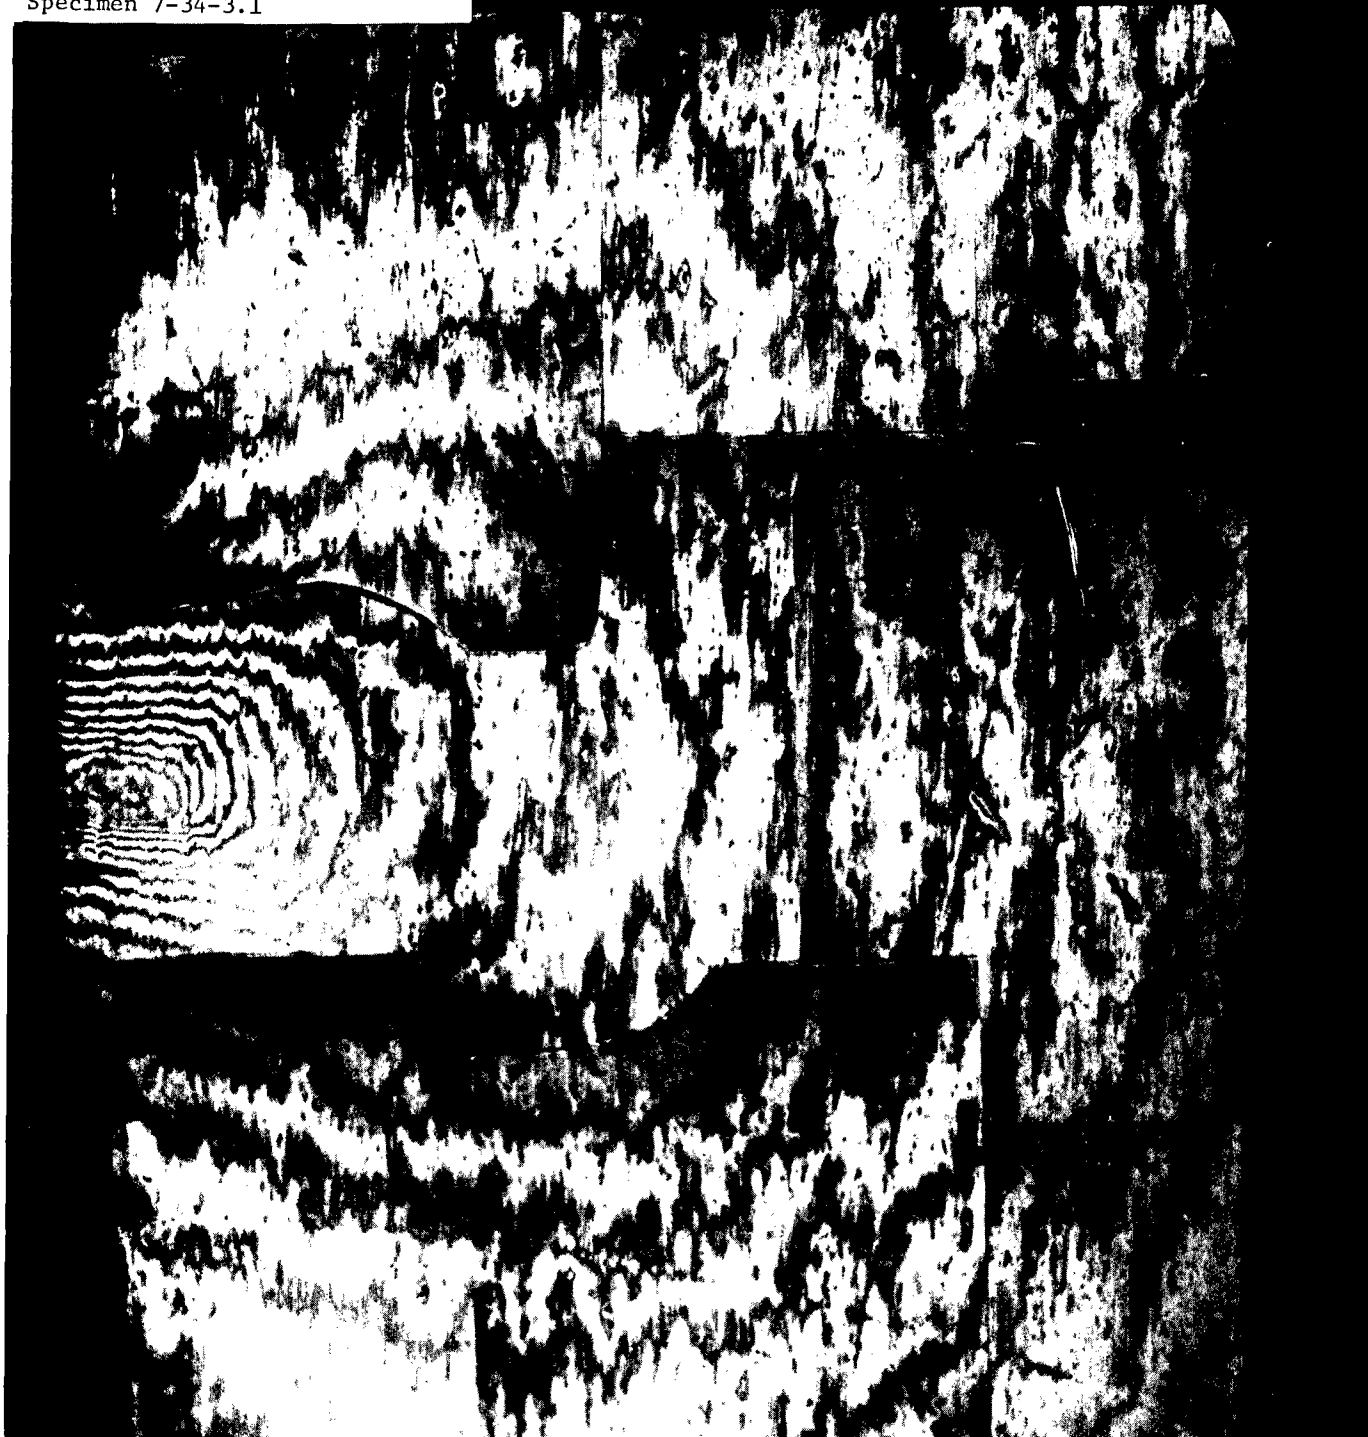
Figure 39. Interferometry Photograph of an Unloaded Crack in a 7075-T7351 Specimen

7075-T7351,  $a = 0.215$  inch  
 $\sigma_x = -1.8$ ,  $\sigma_y = 18$  ksi unloaded  
Magnification: 48.3X  
Test Case 56  
Specimen 7-34-3.1

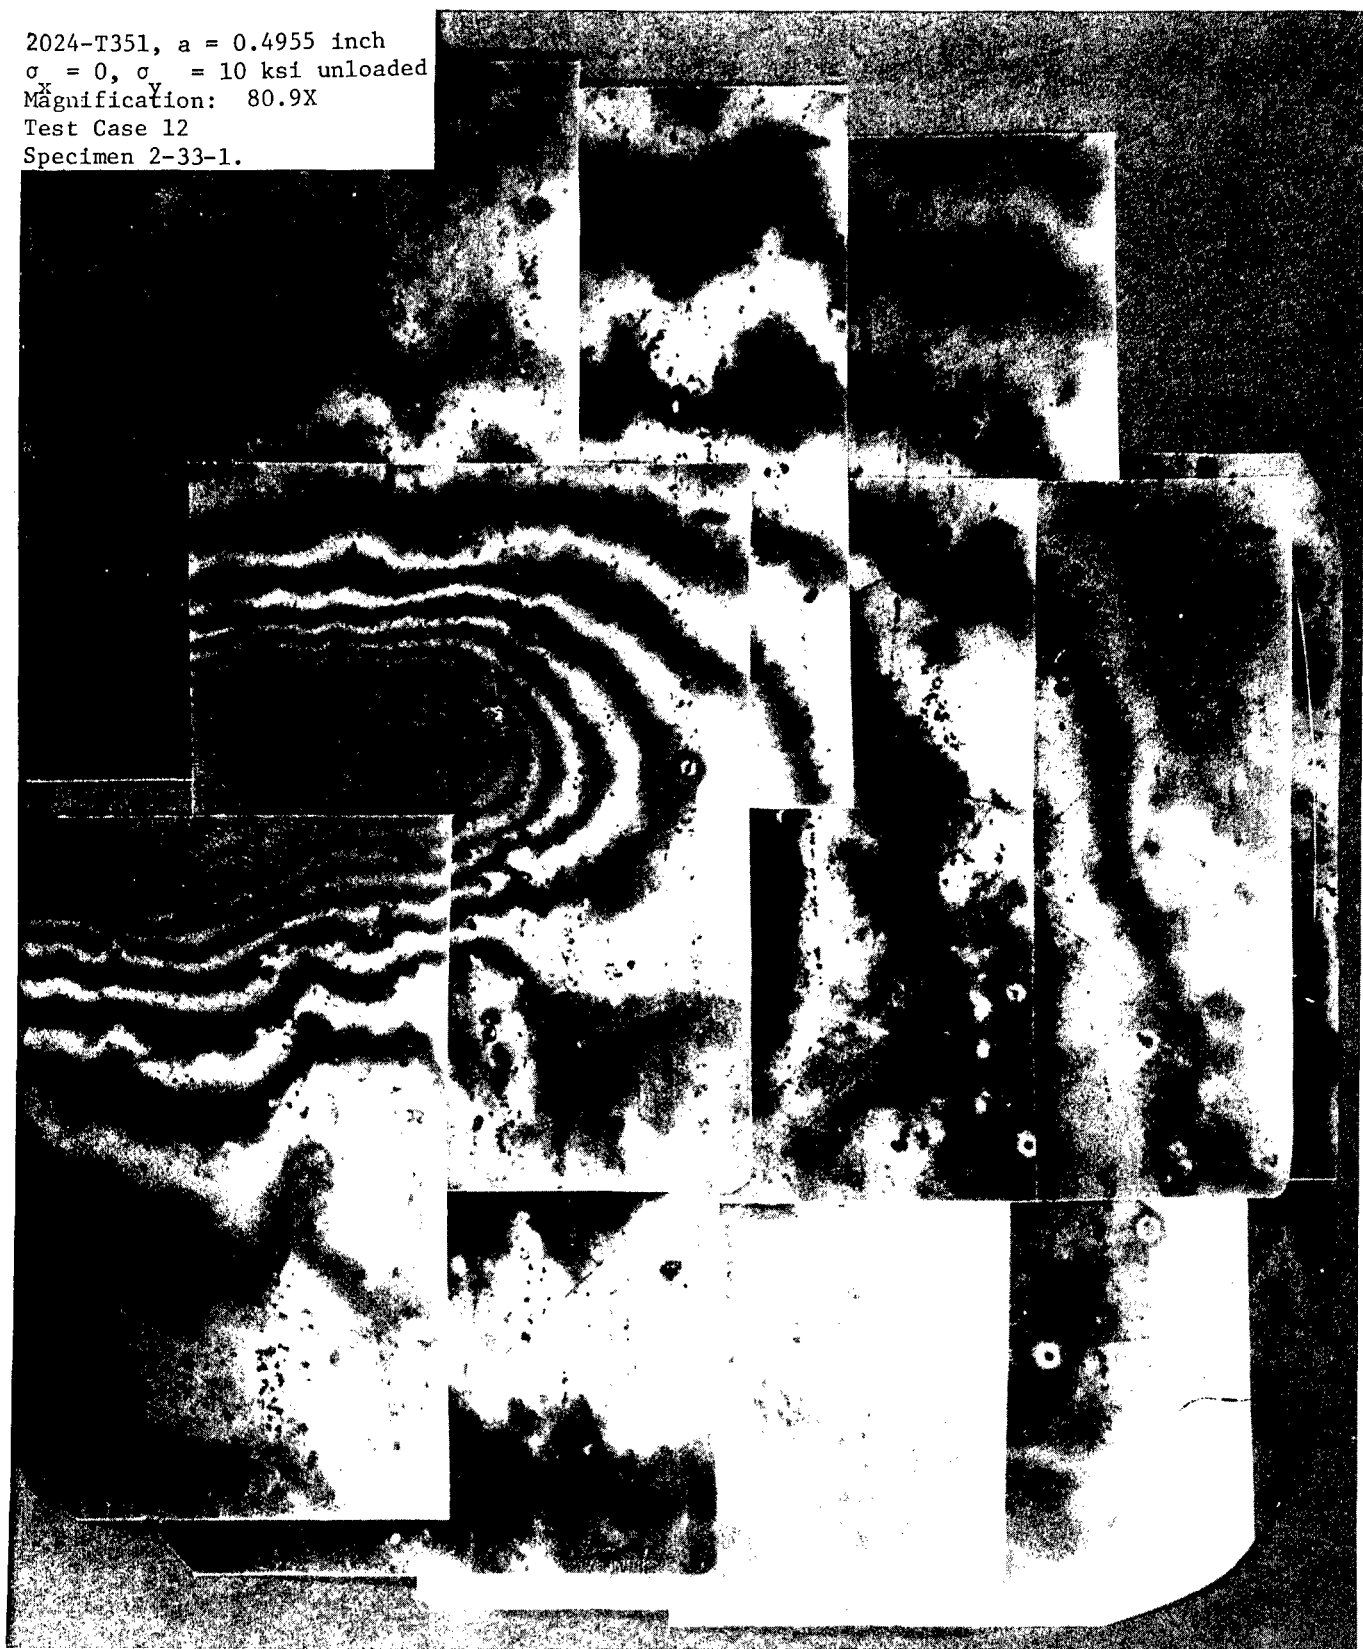
Figure 48. Interferometry Photograph of a Loaded Crack in a 7075-T7351 Specimen

2024-T351,  $a = 0.4955$  inch  
 $\sigma_x = 0$ ,  $\sigma_y = 10$  ksi unloaded  
Magnification: 80.9X  
Test Case 12  
Specimen 2-33-1.

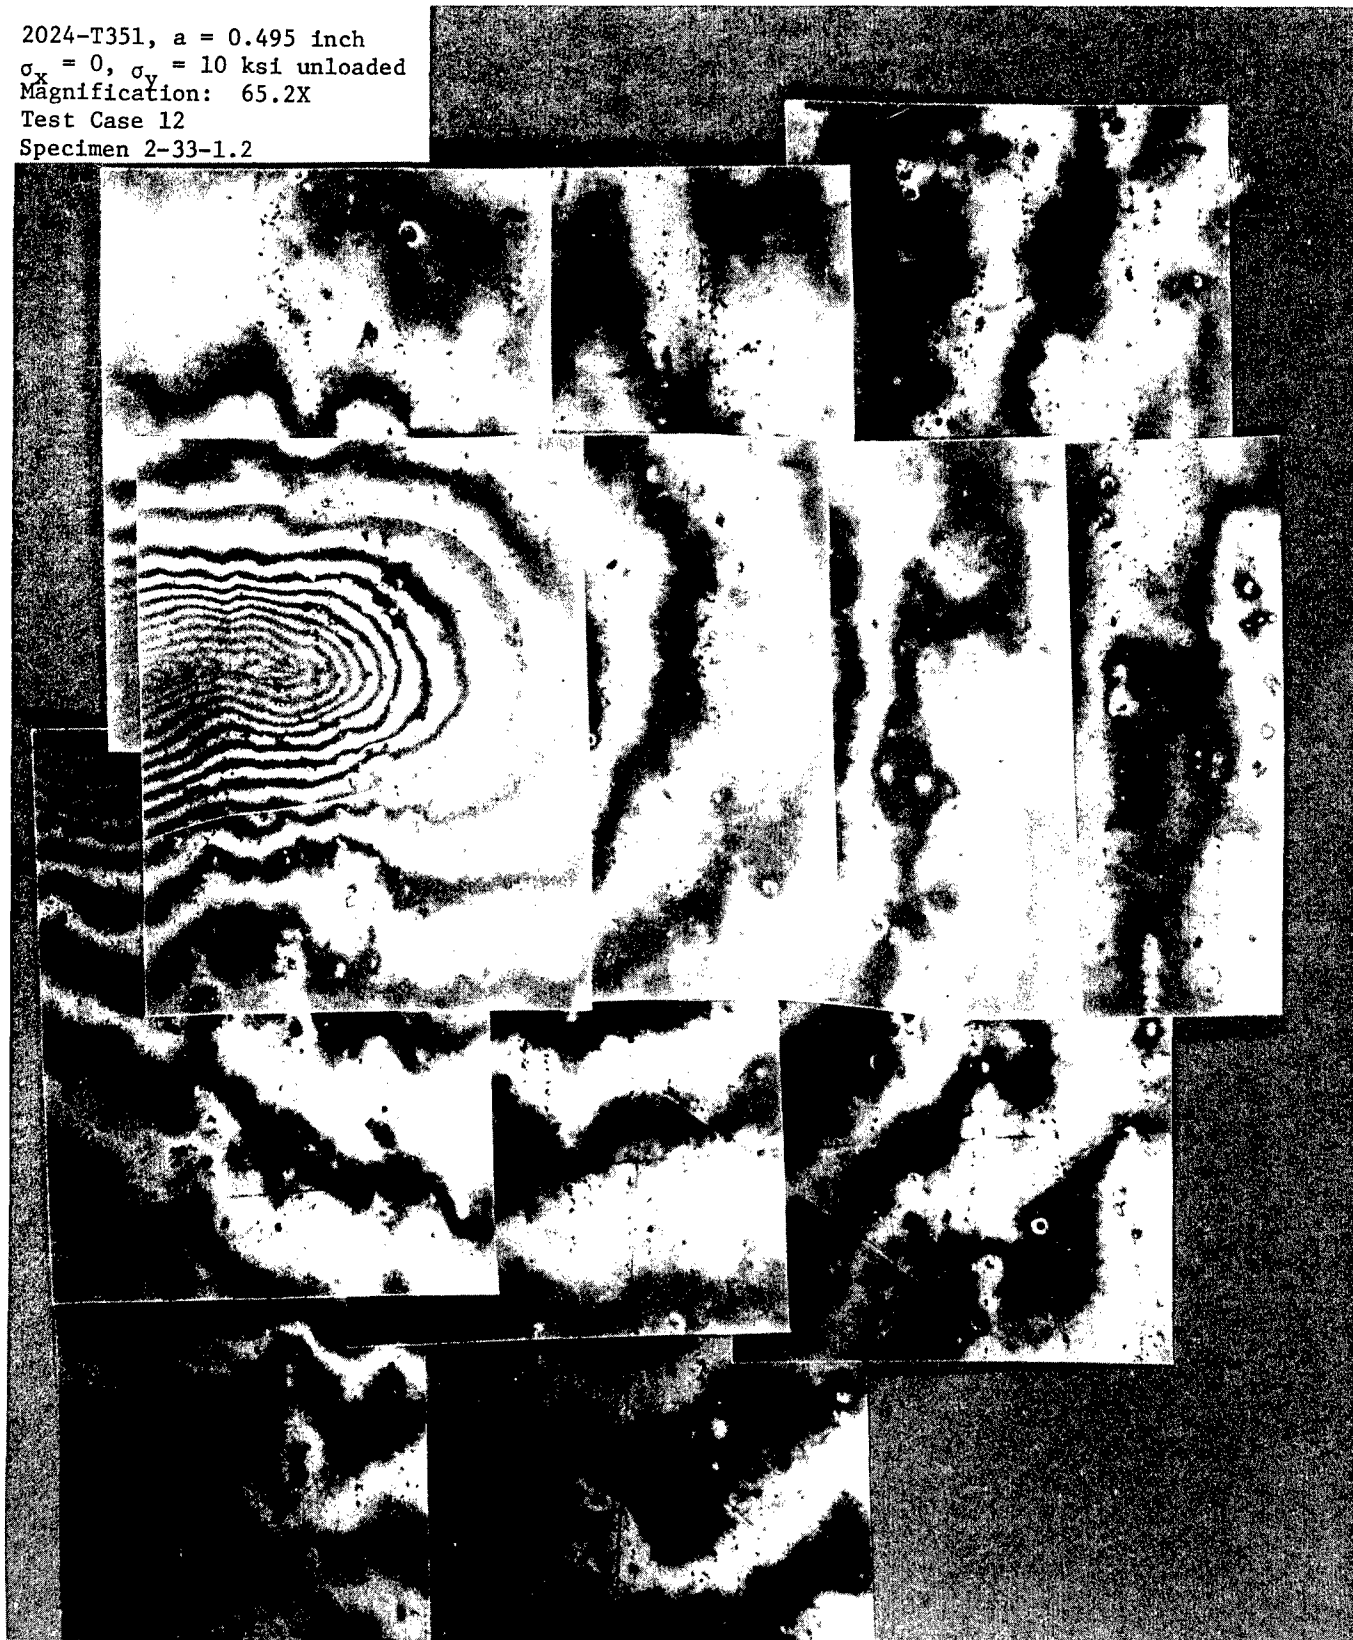
Figure 49. Interferometry Photograph of an Unloaded Crack in a 7075-T7351 Specimen

2024-T351,  $a = 0.495$  inch  
 $\sigma_x = 0$ ,  $\sigma_y = 10$  ksi unloaded  
Magnification: 65.2X  
Test Case 12  
Specimen 2-33-1.2

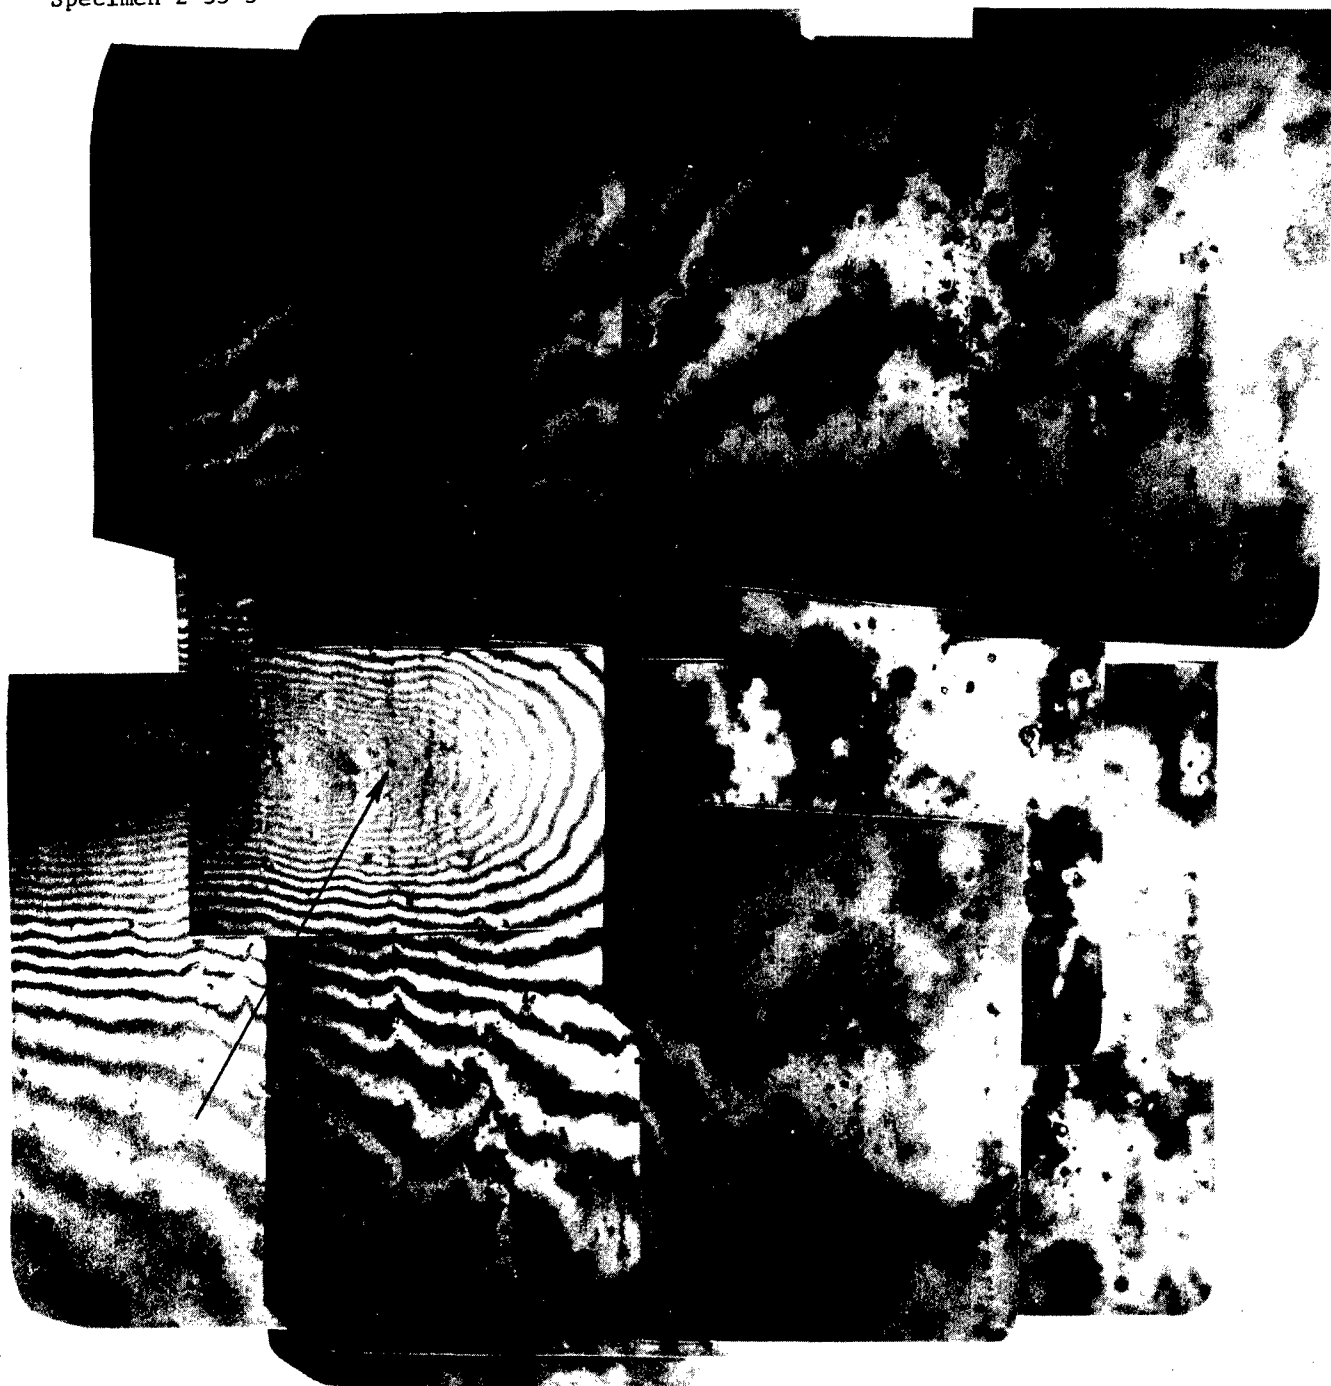
Figure 52. Interferometry Photograph of an Unloaded Crack in a 2024-T351 Specimen

2024-T351,  $a = 0.98$  inch  
 $\sigma_x, \sigma_y = 10$  ksi unloaded  
Magnification : 46.2X  
Test Case 12  
Specimen 2-33-3

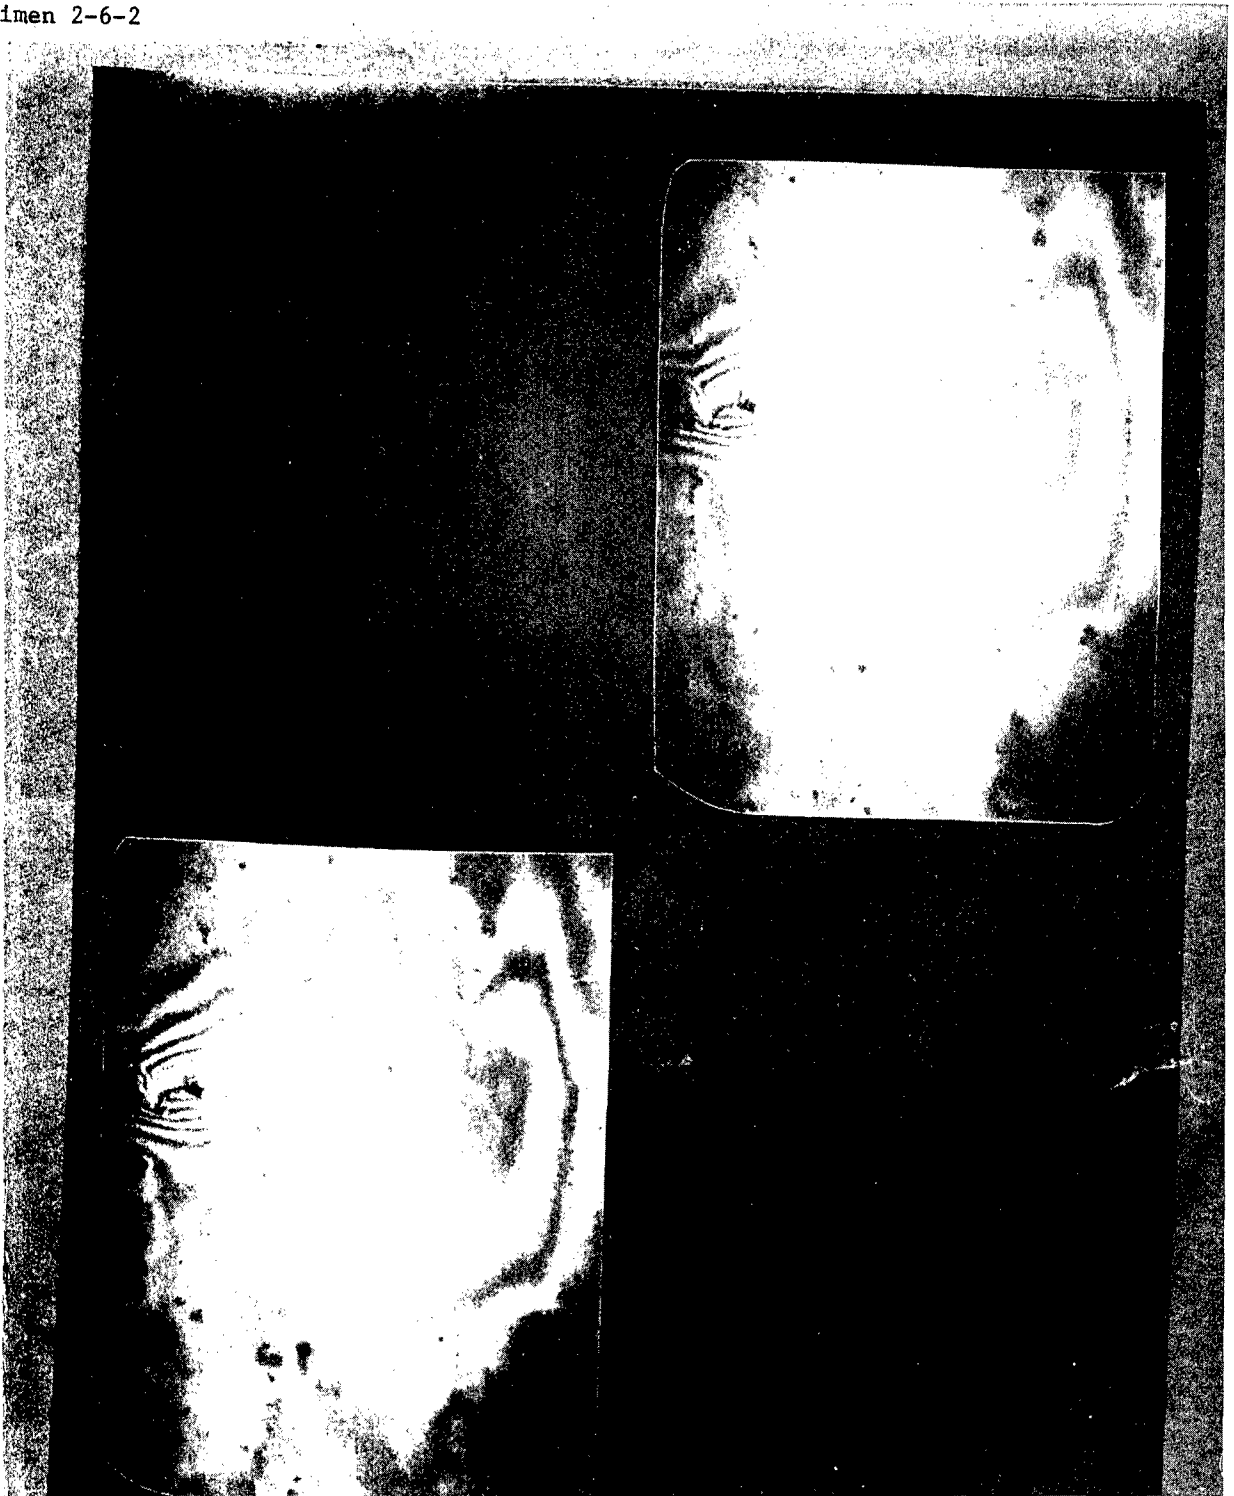
Figure 55. Interferometry Photograph of a Loaded Crack in a 2024-T351 Specimen

2024-T351,  $a = 0.24$  inch  
 $\sigma_x = 0, \sigma_y = 10$  ksi at load  
Magnification: 46.2X  
Test Case 10  
Specimen 2-6-2

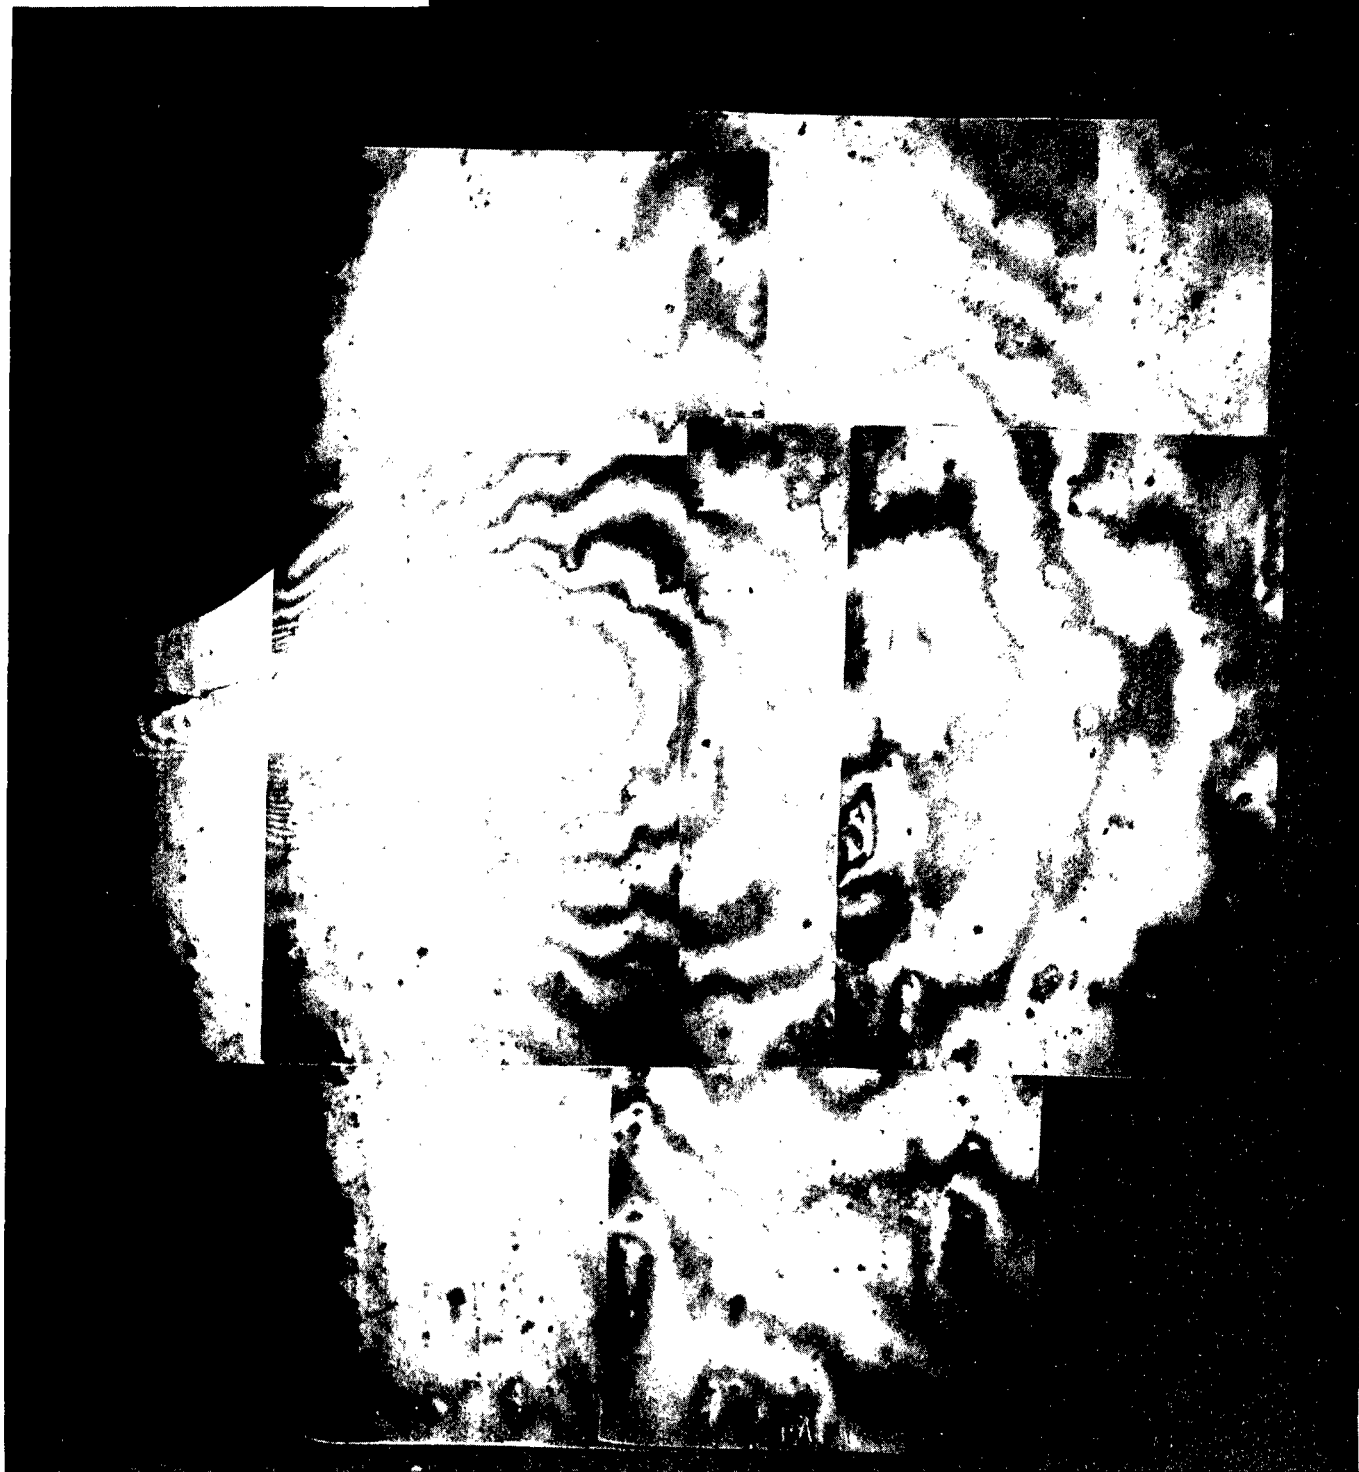
Figure 57. Interferometry Photograph of an Unloaded Crack in a 2024-T351 Specimen

2024-T351,  $a = 0.485$  inch  
 $\sigma = 0, \sigma = 10$  ksi unloaded  
Magnification: 46.1X  
Test Case 10  
Specimen 2-6-4
